NASA CR-167851

MATERIALS FOR ADVANCED TURBINE ENGINES

Project Completion Report Project 3

ADVANCED BLADE TIP SEAL SYSTEM Volume I

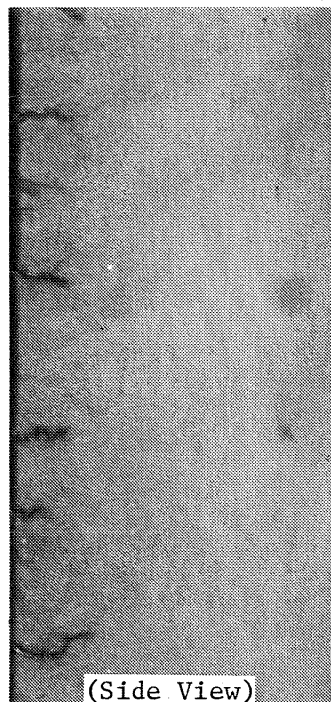
Conventionally Cast Rene' 80

Bare Monocrystal Normalloy

Coated
Monocrystal
Normalloy

Figure 11. SETS Specimens at 740 Cycles.

cracked. All of the uncoated Normalloy specimens exhibited several small cracks. The René 80 specimens had several large cracks extending well into the specimen. Photographs showing the condition of the SETS specimens at 740 cycles are shown in Figure 11.

The results of the SETS testing clearly demonstrated the increased resistance of the monocrystal Normalloy to thermal fatigue relative to René 80.
